## CHAPTER 3. EXISTING CONDITIONS

### 3.1. GENERAL FINDINGS

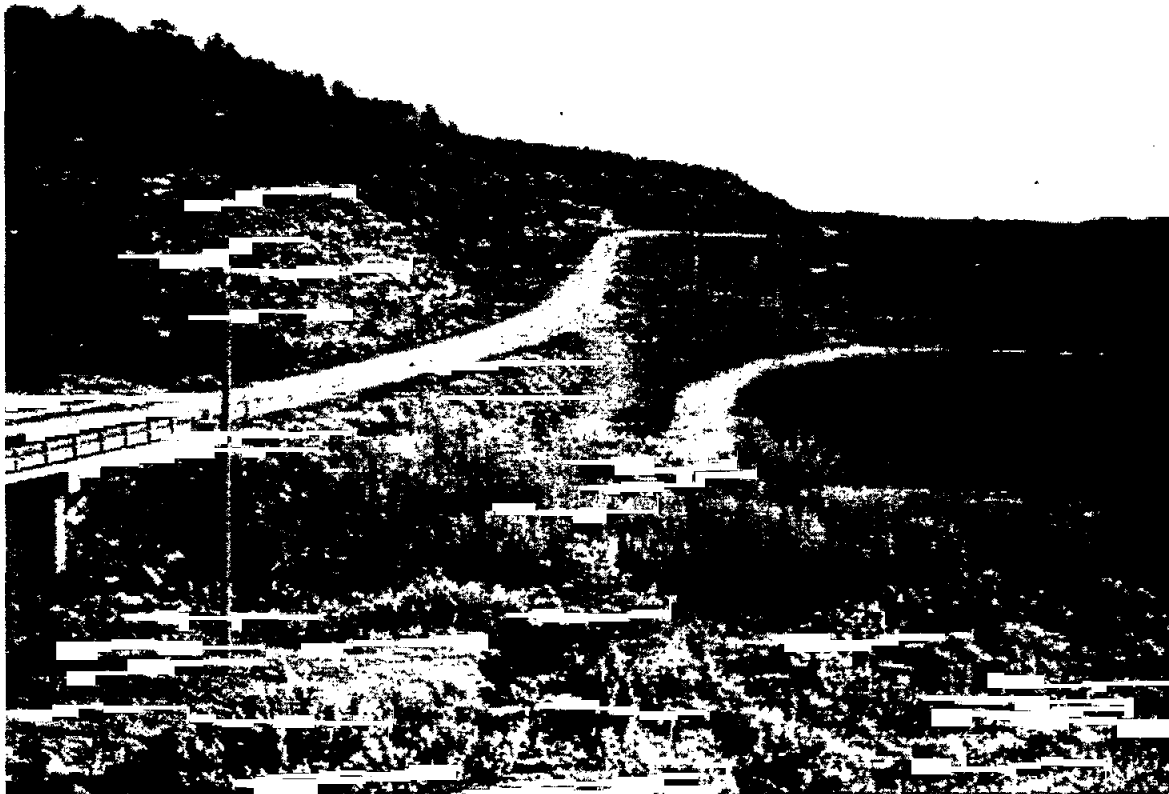
Figure 3-9. —Looking down the La Plata River valley in Segment III, reach 9. Highway bridge at left crosses Long Hollow flowing from the east.

The Boyle Property is located in Segment III, reaches 9 and 10. The property has been greatly altered by past and ongoing earthmoving for river channelization and floodplain management. Subsequently, both the riverine and riparian-wetland environments have been significantly disturbed, with various parts of the property in differing stages of recovery.
